ILDIKO KERTESZ BRINAS
NARCIS IONEL REBEDEA
ILIE LUCIAN OLTEAN

Bucket wheel excavator cutting tooth stress and deformation analysis during operation using Finite Elements Method (FEM)

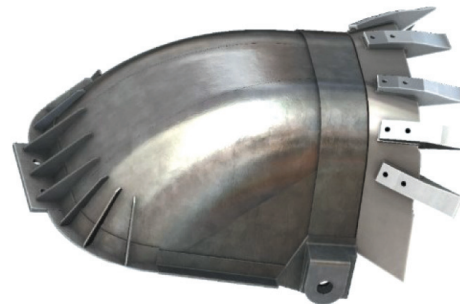
Fig. 4. Bucket with cutting teeth of BWE [8]

- the functional parameters of the excavator,
- the constructive parameters of the cups (Fig. 4) and rotor (Fig. 5),
- the shape and type of cutting teeth used,
- the type of excavated material,
- cost.

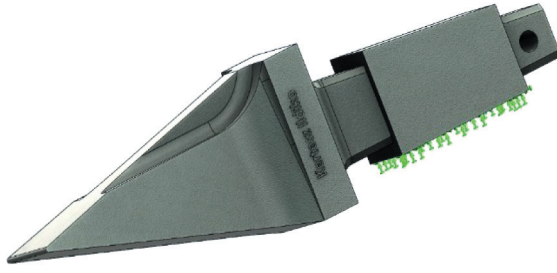
Fig. 8. Fixation conditions of cutting tooth

For a realistic approach, the FEM was conducted on an assembly of a cutting tooth and its cup holder support bracket. When creating this assembly, we set up the geometrical links between the two components. Figure 8 shows the restrictions (fixation condition) imposed on the analyzed assembly.

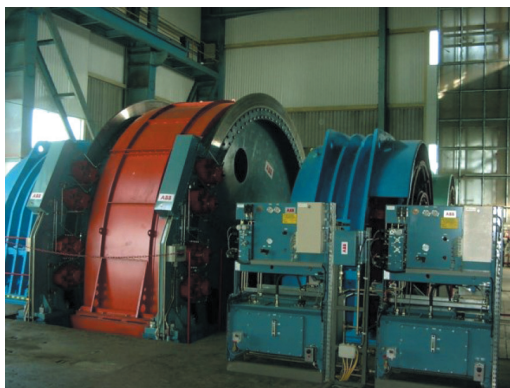
Both hydraulic units of the control and power supply unit of the break are located at the level of the hoisting machine. Figure 1 presents the view of the machine in the (S) section after modernization.

Fig. 1. View of hoisting machine in section (S) of R-II shaft after modernization in 2004 [1]

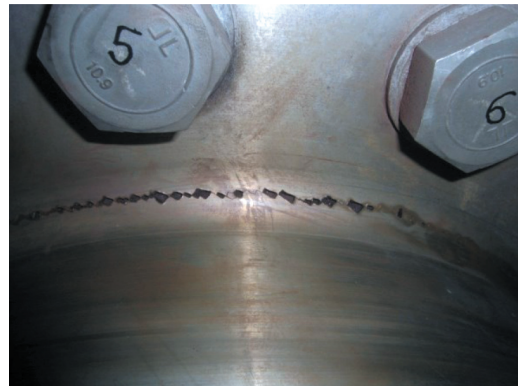
A crack as well as chips of the material in some places were visible along about half of the circumference of the shaft. The nature of the damage indicated fatigue crack (Figs. 2 and 3).

Fig. 2. Cracks in circumference with crushing [1]

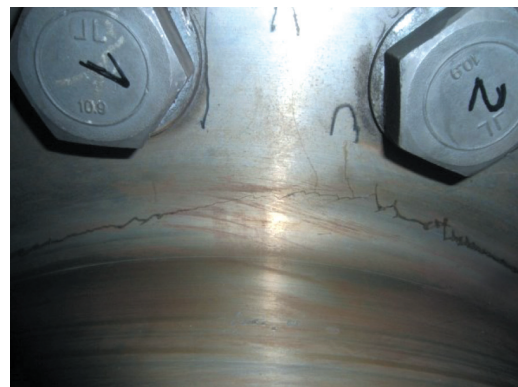
Fig. 3. Cracks on circumference and radial cracks [1]

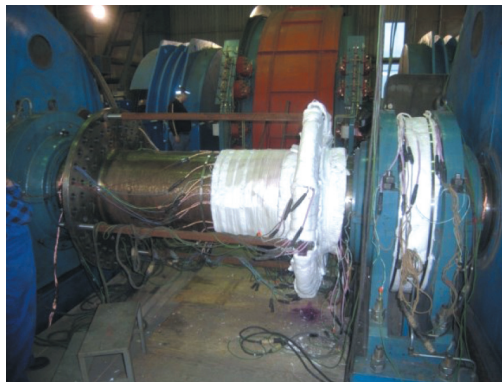
The area around the site of the repair was isolated and then heated up to a temperature of ca. 100°C with an electric heating unit and heating mats at a rate

Fig. 6. Area around place of welding was isolated and then heated up with electric heating unit and heating mats. Heating speed was about 25°C/h [1]

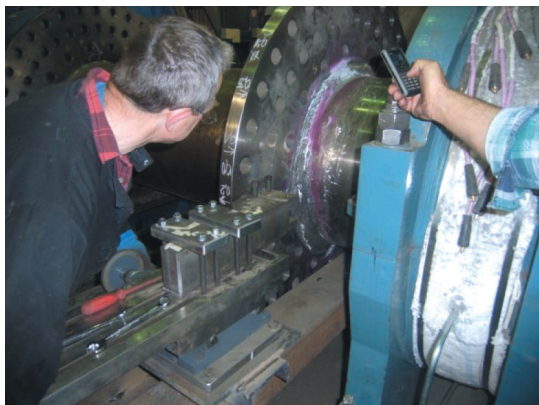
Fig. 9. Machining of shaft after welding to render proper curvature radius for part of shaft [1]
